MV ESTONIA Accident 28.9.1994

Summary

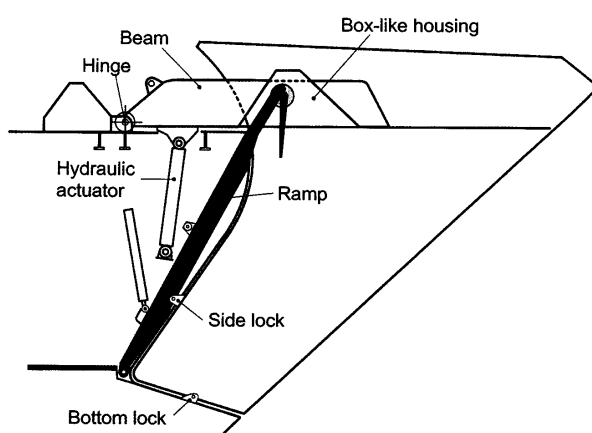
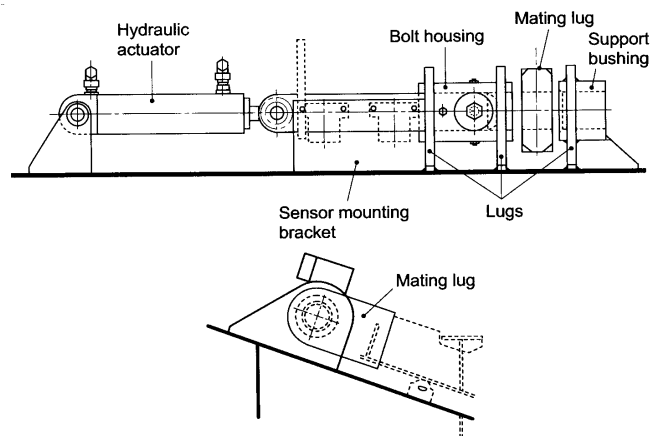
- The accident was initiated by failure of the bow visor attachments under wave impact loads.
- The failure was primary due to local overload. The attachments were not designed to withstand even the rather moderate wave condition at the time of the accident.
- Bureau Veritas had no detailed rules for design of visor locking devices and hinges. BV requested the locking devices to be approved by Finnish Administration.
- The Finnish administration did not make any hull surveys because the ship was classed under the rules of an approved classification society.
- The shipyard made rough estimates of wave loads according to other guidelines and rules available at the time (but which later have been significantly strengthened up). The assumptions made did not reflect realistic load distributions.
- The locking devices were not manufactured properly according to the design intent.

- Strict routines for identification (FSA), design and inspection of vital safety components.
- Upgrading of existing vessels according to new requirements based on research and experience. (The strength of the visor locking devices would have been 5 - 10 times higher if 1994 rules would have been applied).
- Learning by experience: DIANA II suffered severe damage to the visor attachments after heavy weather in January 1993. More than 14 roro / pax ferries have had incidents or even complete failure of visors before the ESTONIA. A Swedish Maritime Administration surveyor have reported that the visor attachments are far to weak on many ferries already at the time of newbuilding of the ESTONIA.

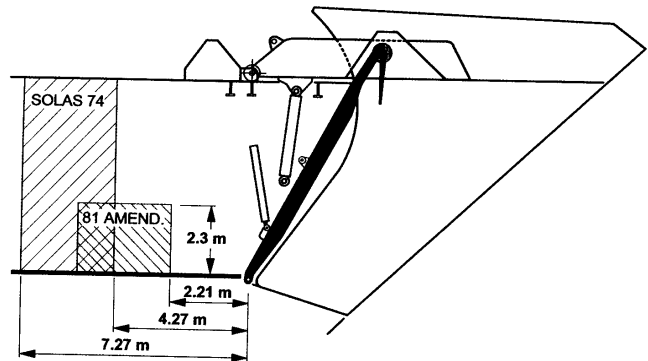
- The forward ramp was integrated in the visor structure and was thus forced open when the visor attachments failed.

- There was no collision bulkhead extension in proper position according to SOLAS. The ramp was located too far forward to fulfil the requirements.

- Strict routines for compliance with SOLAS.
- Learning by experience: The HERALD OF FREE ENTERPRISE accident highlighted the risk with water on deck on roro / pax ferries.
- Training: The crew should have been trained for immediate actions in case of possible water ingress. Correct actions at the time of the first indications (reported sounds from the bow) would have saved the ship.
- Relevant alarm indicators on the bridge would have showed when the visor was detached.

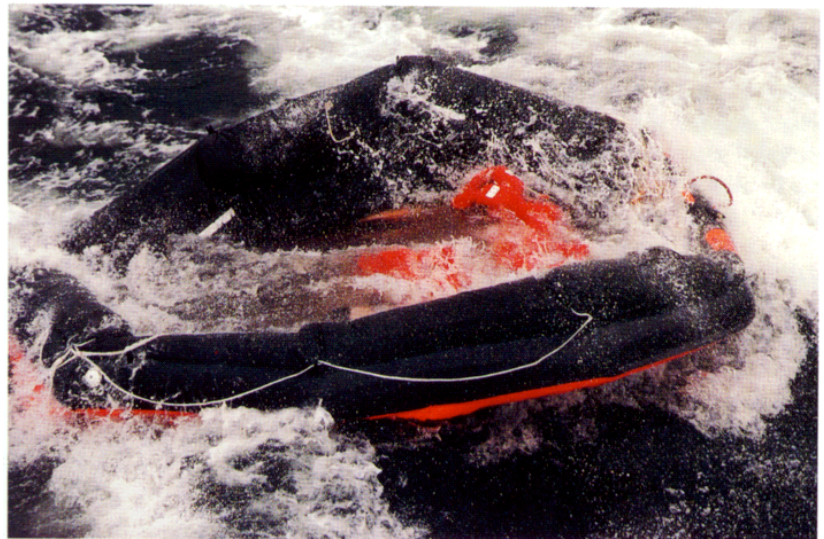
Figure 17.8 ESTONIA liferaft drifting upside-down.

- None of the lifeboats could be launched properly. It was difficult to launch life rafts and most of the rafts was water trapped or overturned at sea.
- Assisting vessels did generally not find it possible to rescue people from the sea.
- The first helicopter arrived about 90 minutes after evacuation had become impossible. The capacity of helicopters was limited as most of them could not land or lower survivors onto the surrounding ships. Only one helicopter managed to rescue more than 15 people in total.

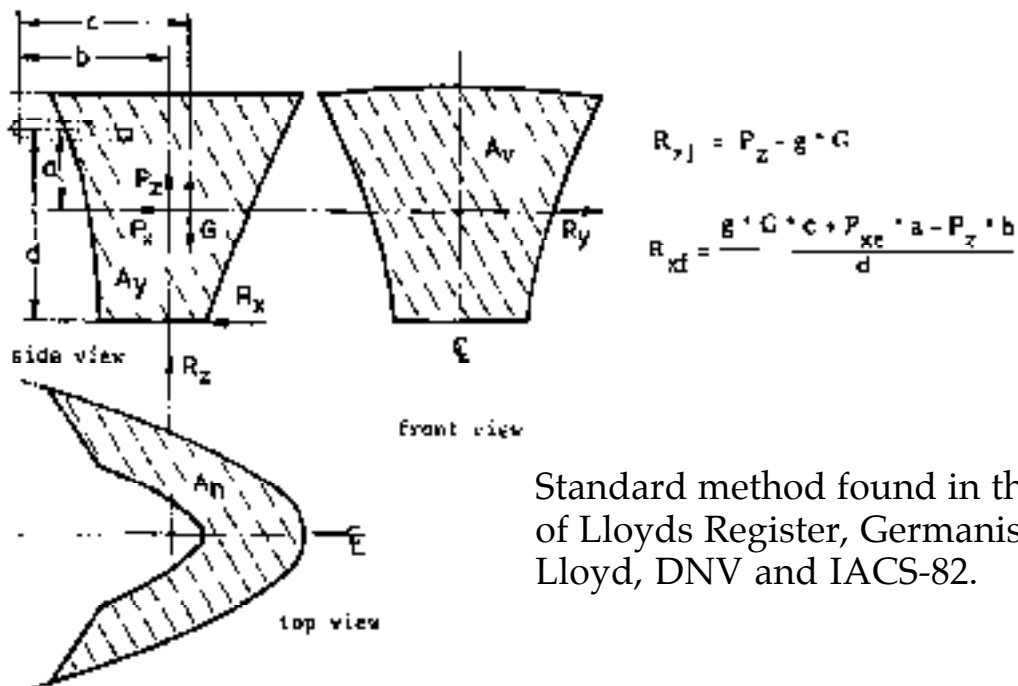
- Bureau Veritas had no rules for design of visor attachments, they made a note on the drawing that the locking devices should be examined and approved by the national authority. However the Finnish Maritime Administration did not examine the installation as the ship was built according to the rules of an approved classification society.
- The shipyard made hand calculations of required cross sectional area of all attachment points (3 locks, 2 hinge points) assuming HT-Steel (St52-3) as requested by Bureau Veritas.
- The calculation was made similar to what was proposed by other class societies but the load distribution seems to have been misinterpreted.

Standard method found in the rules of Lloyds Register, Germanischer Lloyd, DNV and IACS-82.

- A design wave pressure on projected areas of 54 kPa was used in shipyard calculations. (LR-78 would have given 30/60 kPa, GL: 157 kPa.) A resultant design load of 1 MN per attachment was calculated giving a required cross sectional area of 6100 mm².
- The actual installation found was made of mild steel and the cross sectional area of the bottom lock was significantly less than required.
- Analysis of the ultimate strength in the installation as found gives approx. 1.5 MN for the bottom lock, 1.2/1.6 MN for side locks and 5-7 MN per hinge point (dependent on the load direction).
