MV ESTONIA Accident 28.9.1994

Summary

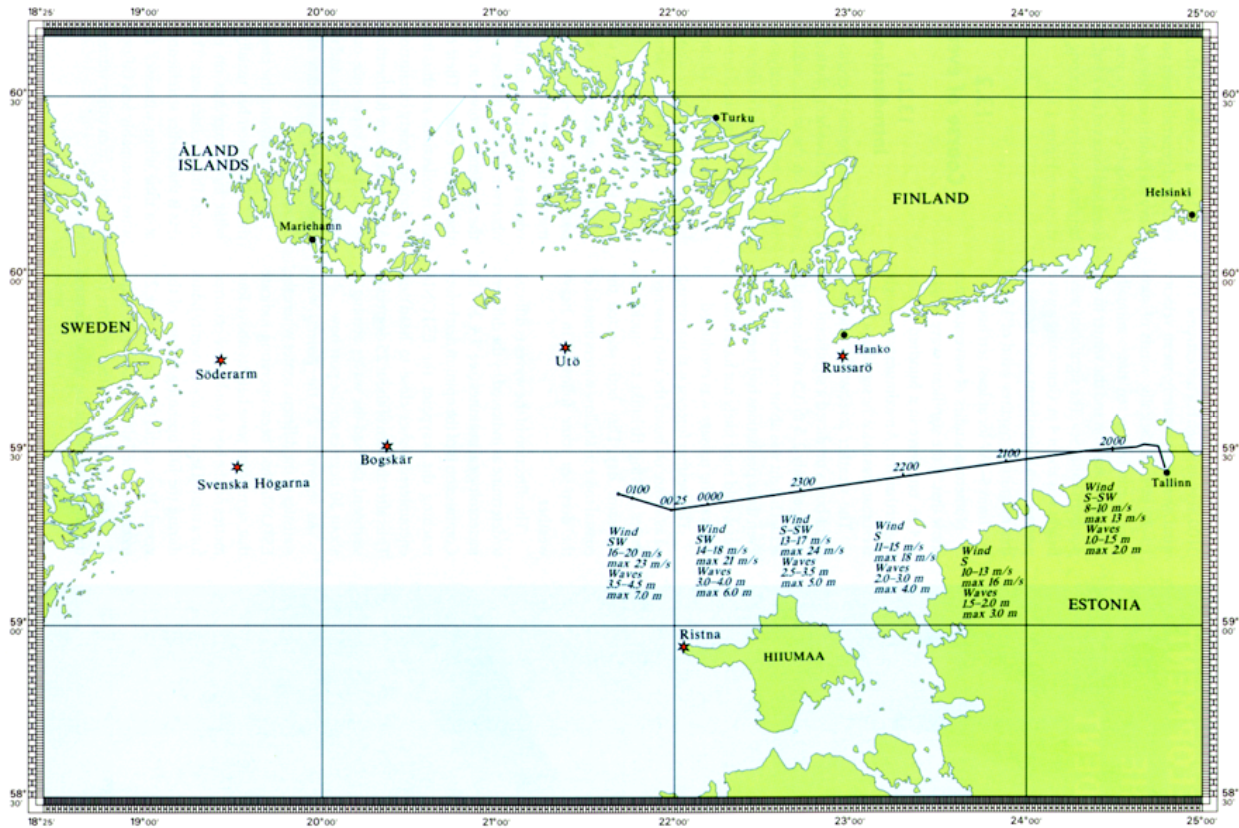
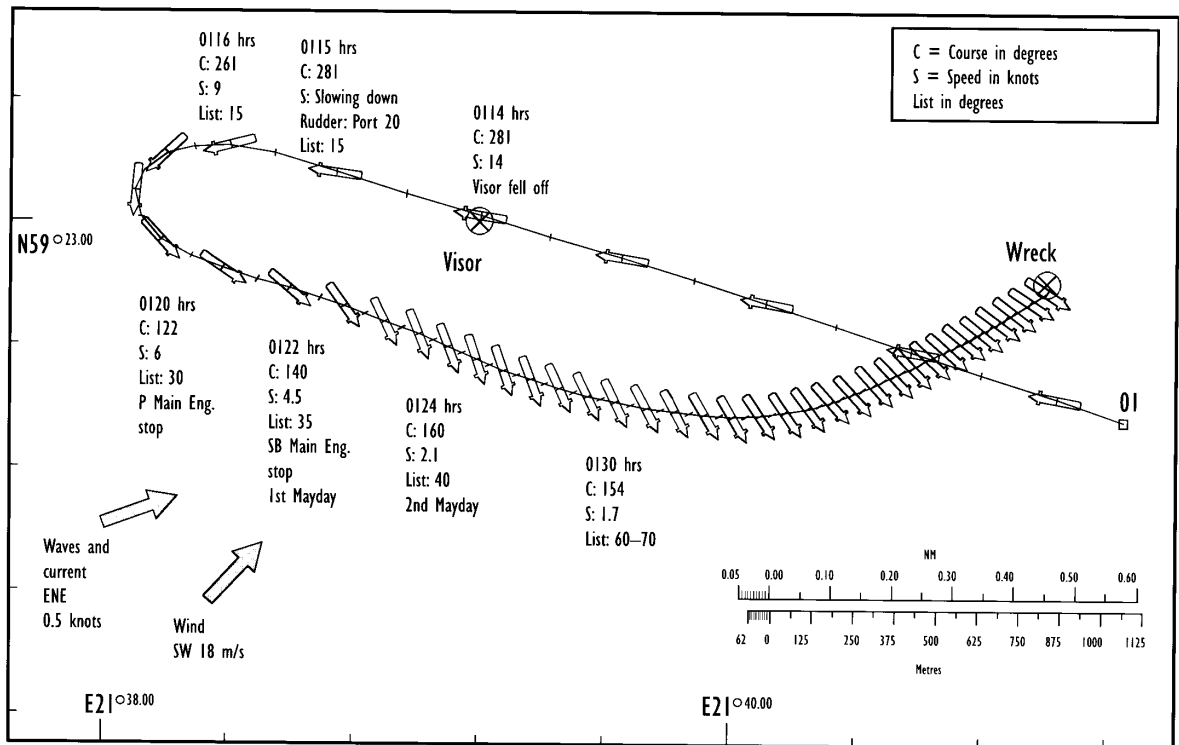
Sequence of events

- The ramp had been forced open by the detached bow visor whose attachments had failed due to wave impact loads about 10 minutes before the water ingress started.

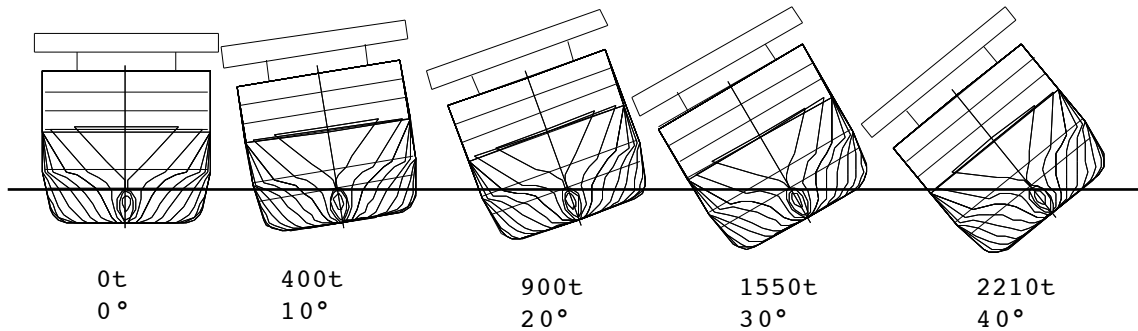
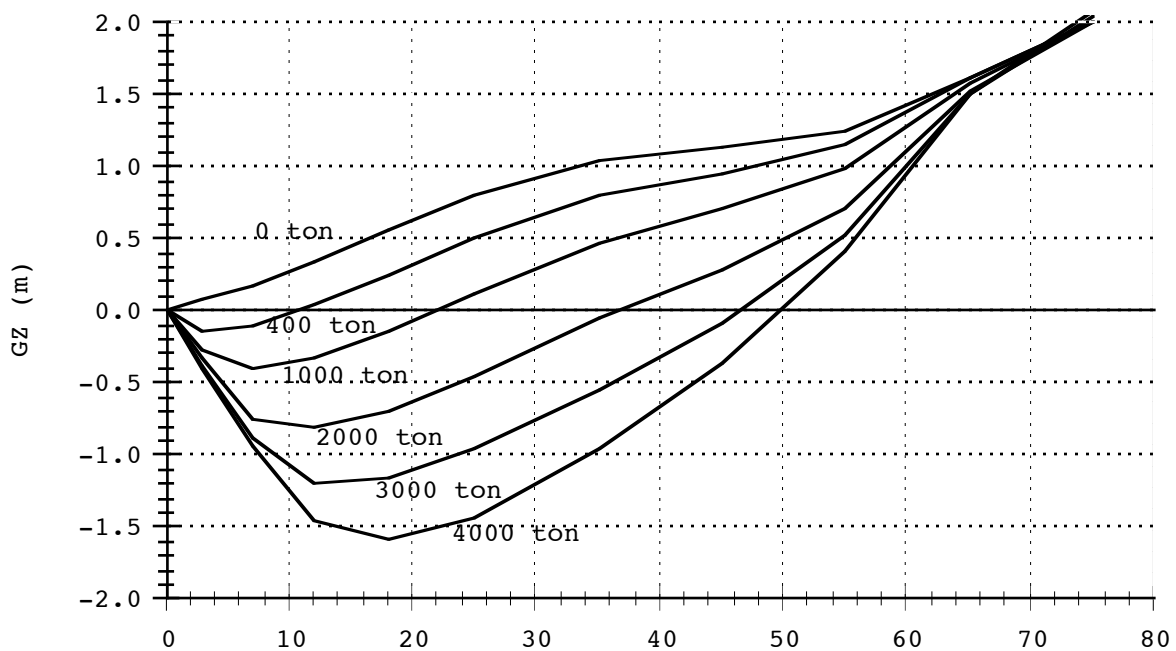
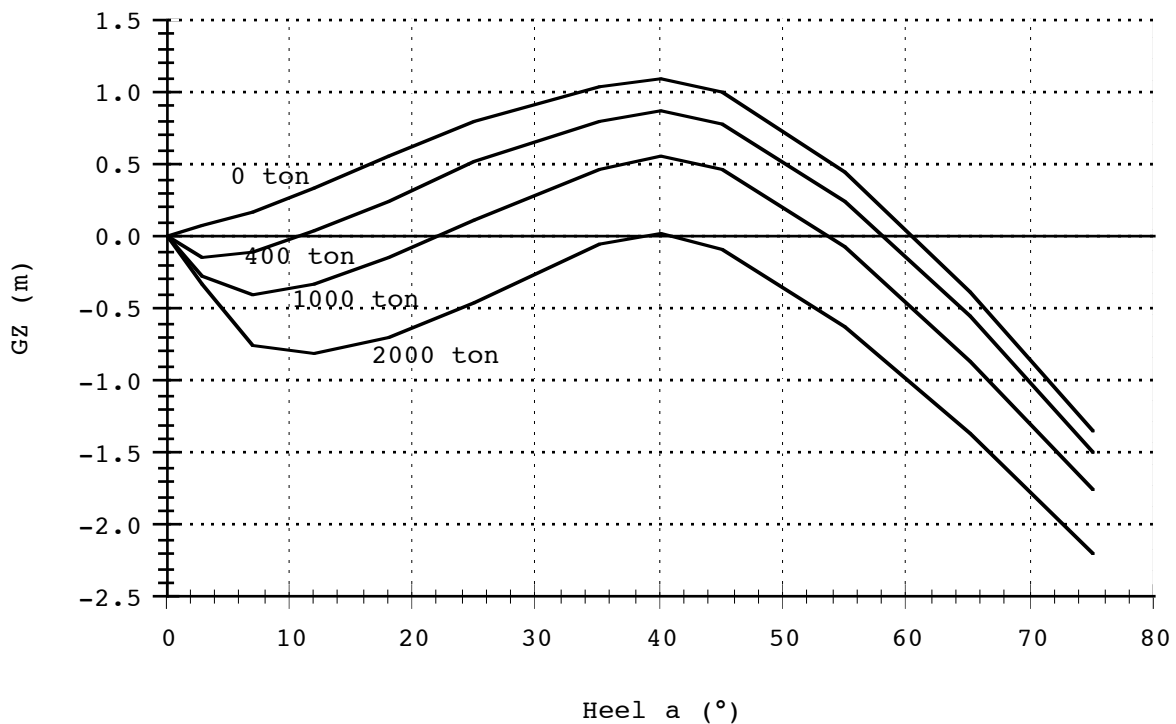
Analysis of the capsizes – Stability during water ingress

- The list developed rapidly, it became 15° within only a few minutes and over 40° within 15 minutes.
- The narrow passages in accommodation areas and the staircases quickly became crowded with injured and panic-stricken people. It was almost impossible to reach open decks when the list was more than 30°. Only about 300 people reached outer decks.
- The lifeboat alarm was not given until about five minutes after the list developed. No information was given to passengers over the public address system.

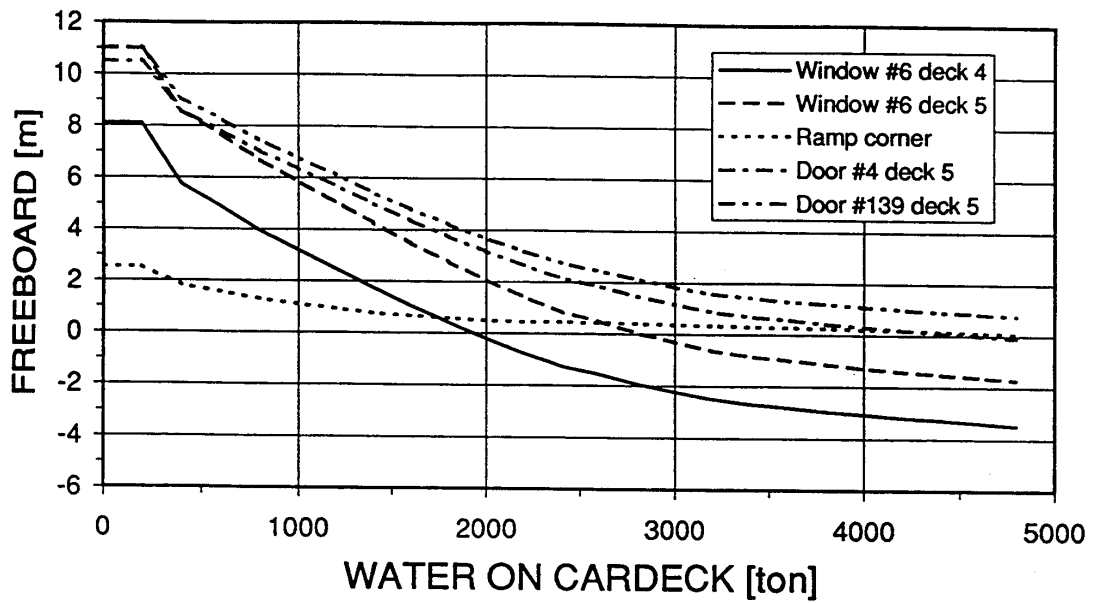
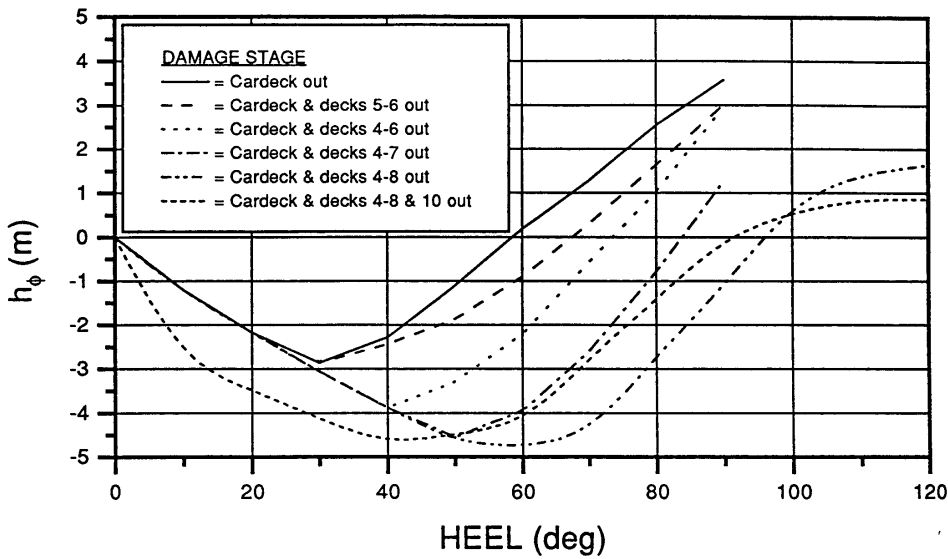
Analysis of the capsize – Progressive flooding

- The fully open car deck on these ro-ro ferry designs make them extremely sensible to water ingress.
- The officers did not reduce speed or change course when the first indications of something being wrong at the bow or the forward part of the car deck was given.
- The bow visor could not be seen from the conning position, and the indicator lamps for locked visor did not detect the failure of the locking devices.
- The ship was turned towards the waves when the ship started to heel over.
- The rapidly developed list to starboard could not be compensated by the heeling tanks since the port tank already was full at departure.
- The buoyancy reserve in the superstructure diminished when windows and doors broke and progressive flooding started from aft/above.
